RESULTS OF ENVIRONMENTAL TESTING OF MODIFIED OH-58A TAIL ROTOR DRIVE SHAFT BEARING ASSEMBLIES

D. J. Ward
BELL HELICOPTER COMPANY
Post Office Box 482
Fort Worth, Texas 76101

30 October 1970

REPORT NO. 206-097-005

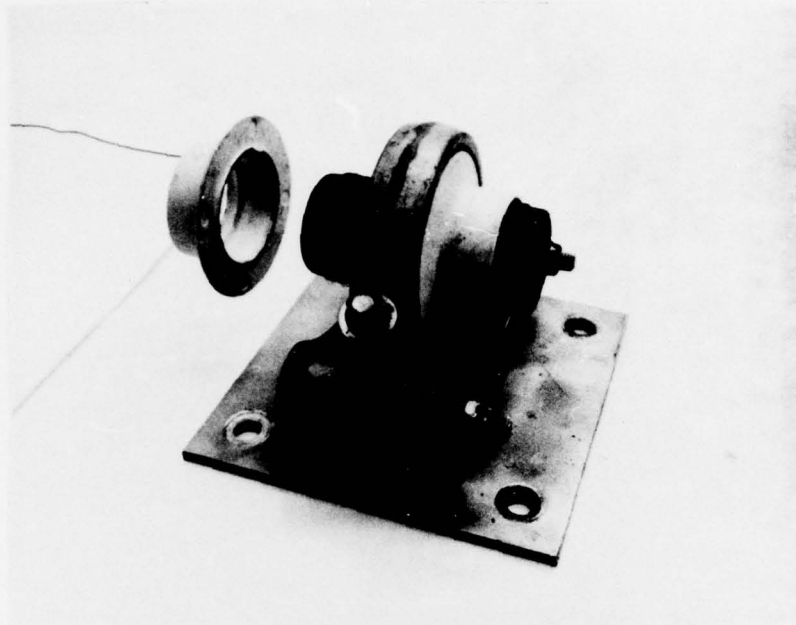
Figure 1

Proposed Bearing Assembly Configuration

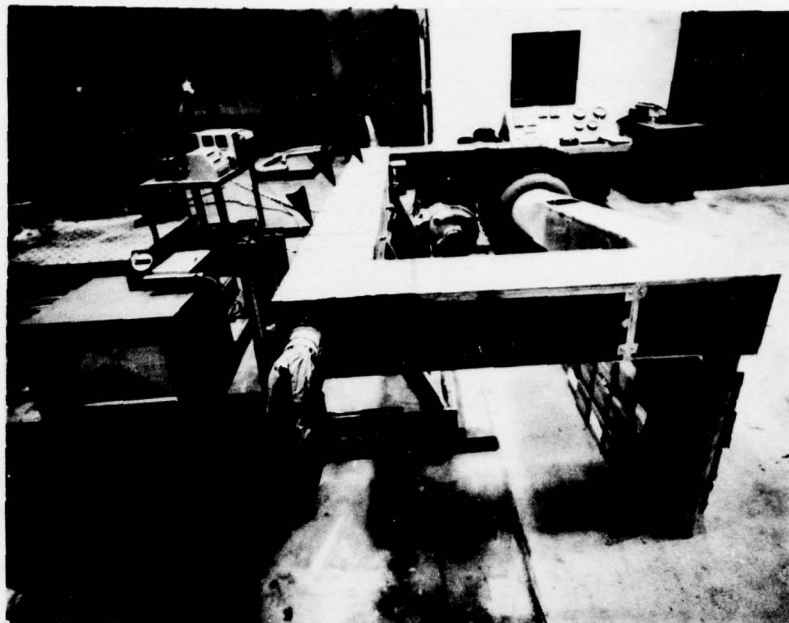
Figure 2

Test stand with top in place. Arrows indicate plexiglass inspection windows. Honeywell temperature recorder and test timer are on left.

The test stand was built out of 10" square conduit laid out into a rectangular closed duct. Air was circulated within the duct by a 30" diameter centrifugal blower driven by a 30 hp Varidrive. A means of metering test dust into the duct was incorporated on the outlet side of the blower. The test shafts were so located that the test dust impinged on bearings #1 and #2 directly from the side. The test dust then turned and passed over the remaining bearings in an axial direction impinging directly on the seals. The shaft curvature attitude and alignment simulated the installation on the OH-58A as closely as possible. The portion of the shaft aft of the last bearing hanger was cut off to facilitate installation in the test stand. Two of these shafts were installed in the test stand side by side. The test shafts were driven from their forward splines from a modified fan sheave through a metallic flexible coupling. Special felt seals were used where the modified fan sheave passed through the duct. A 3/4 hp induction motor was used to drive the test shafts at 5700 rpm. Thermocouples, installed at the split line of each bearing hanger, were monitored one minute out of every six by a 24 point Honeywell Recorder. The recorder was set to stop the test if any bearing reached 250°F. Ambient temperature in the duct was measured by a probe type thermocouple installed over the bearings at positions #7 and #8. The air velocity in the duct was measured by a pitot tube installed in the side of the duct. The pitot was connected to two water monometers reading static and dynamic pressure in the duct.

Testing of all bearing assemblies was accomplished by running them at 5700 rpm in the wind-tunnel-like apparatus shown in Figures 2 and 3. Air cleaner test dust conforming to SAE test specification J726A was introduced on the following schedule. Upon starting test at 0800, add 1/2 pound fine dust, and at noon add 1/2 pound coarse dust. The test was shut down before leaving at night. The dust/air mixture was directed into the side of bearing positions 1 and 2, then over 3 and 4 at 25 mph, over 5 and 6 at 42 mph, and over 7 and 8 at 78 mph. Airflow was produced by a 30-inch centrifugal fan powered by a 30 hp Varidrive (Fig. 11). Temperature of each bearing assembly was measured at the split line of the hanger assembly by thermocouples routed out of the test section to a 24-point Honeywell temperature recorder set to record one minute in six (Fig. 12). Due to the stabilizing effect of the large air mass flow passing over the test bearings, only minor temperature variations could be observed between individual test bearings. Even at the point of bearing failure, only 20 to 30 degrees Fahrenheit temperature increase could be detected. It was necessary, therefore, to maintain close scrutiny of the test in order to detect failure by a minor change in a bearing's temperature level, or by an increase in sound level, or by physical signs of catastrophic failure. Ambient temperature in the test box stabilized at 140 to 150 degrees Fahrenheit. Bearing temperatures were generally 140 to 170 degrees Fahrenheit.

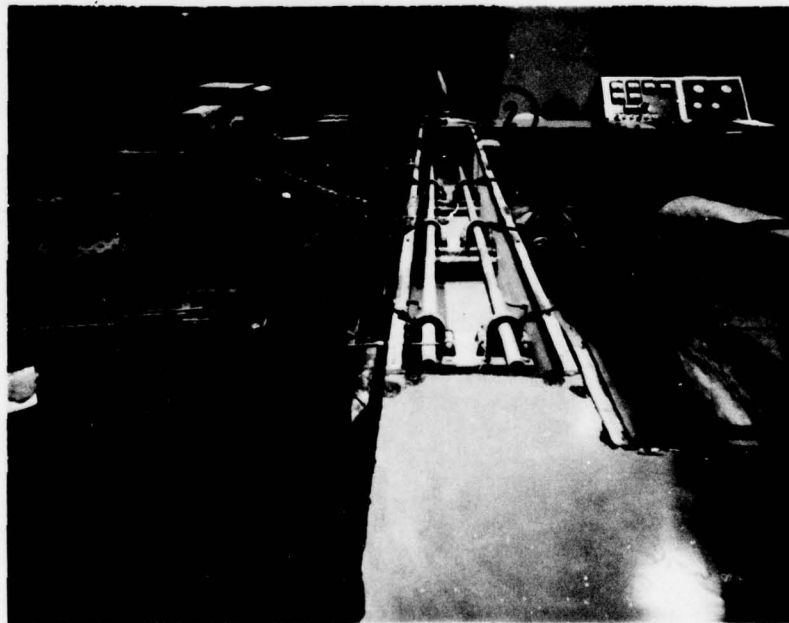
Figure 3

Test stand with top removed. Numbers indicate sequence of numbering of test bearing positions. Also note wind velocity manometers, pitot tubes and thermocouple wires.

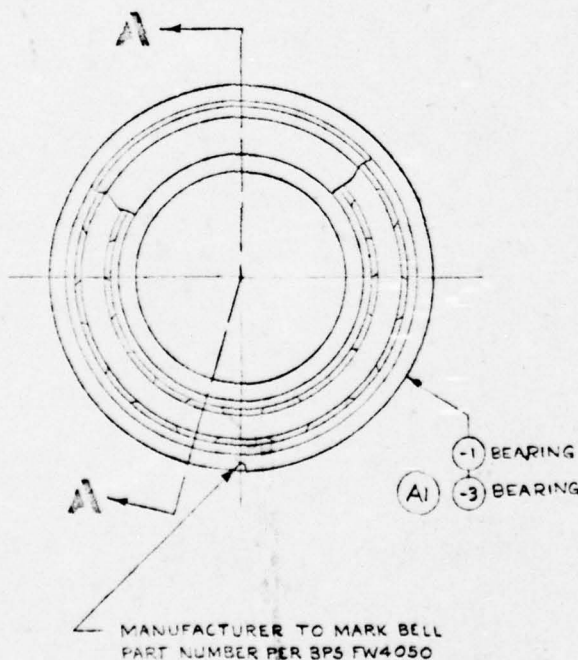
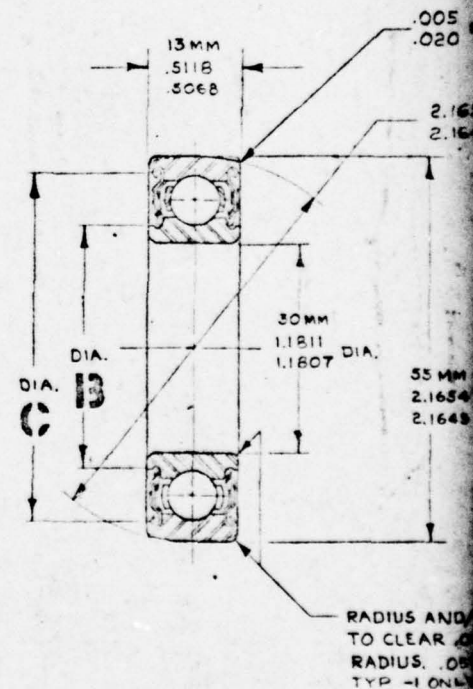
Figure 4

BEARING DATA

MANUFACTURER	FAFNIR BEARING CO. (S)
MANUFACTURER CODE IDENT. NO.	21335
MANUFACTURER DESIGNATION (-1)	P 910G NPP E-9202 (C)
(A1) MANUFACTURER DESIGNATION (-3)	P 910G NPPB E-9202 (B1)
TYPE OF BEARING	SINGLE ROW - BALL, SEALED
RACE CURVATURE: INNER	52% (REF.)
OUTER	54% (REF.) (C)
NUMBER OF BALLS	11
BALL DIAMETER	3/32
BALL MATERIAL	AMS-7440
BALL TOLERANCE GRADE (AFBMA)	25
INTERNAL RADIAL CLEARANCE	.0006 - .0010
FACE RUNOUT: INNER	-
OUTER	-
AXIAL PLAY	.008 MAX.
GAGE WEIGHT	5.5 LBS.
TOLERANCE CLASS	ABEC-1
BASIC DYNAMIC CAPACITY (AFBMA)	2230 LBS.
RING MATERIAL	AMS-6440 OR 6441
RETAINER TYPE	2 PC. PRESSED ~ SPOT WELDED
RETAINER MATERIAL	STEEL
DIA. "B"	1.373 (REF.)
DIA. "C"	1.968 (REF.)
PITCH DIAMETER	1.673
(A2) LUBRICANT TYPE	ALFA-MOLYKOTE 343X
LUBRICANT QUANTITY	1.5 ± .20 GRAMS
(A) HEAT TREAT SPEC. 2	HT-1B, PARA 2 & HT-22, PARA 2 (C)

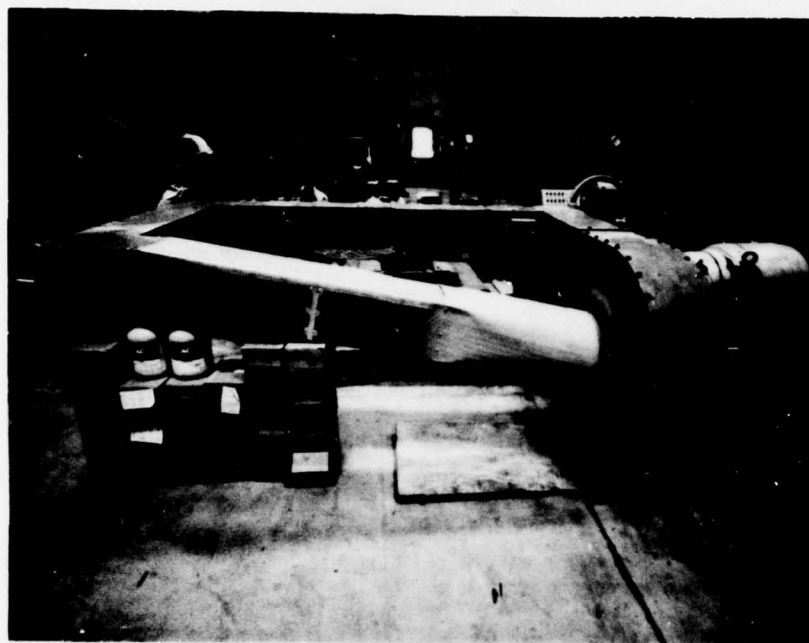
Figure 11

Test stand showing 30" centrifugal blower and supply of test dust.

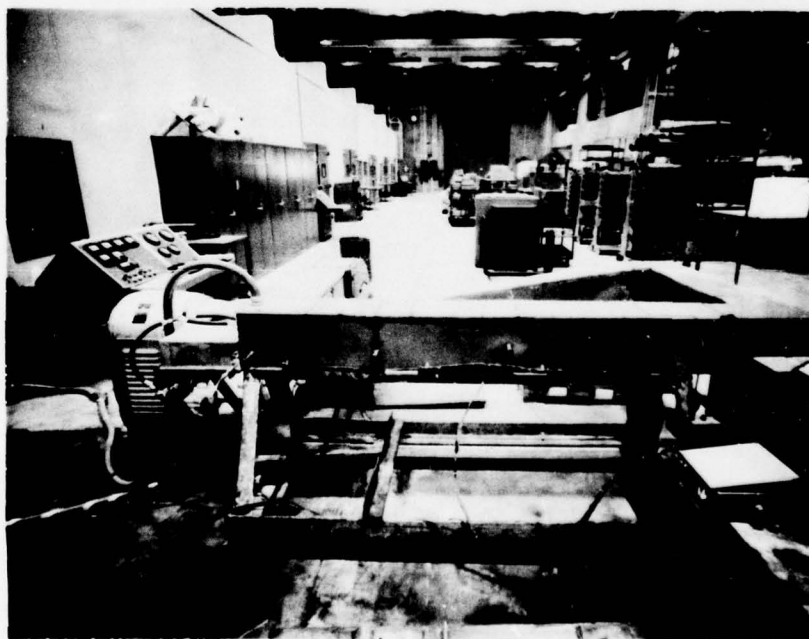
Figure 12

Details of the drive motor for the test shafts and thermocouple wire installations.

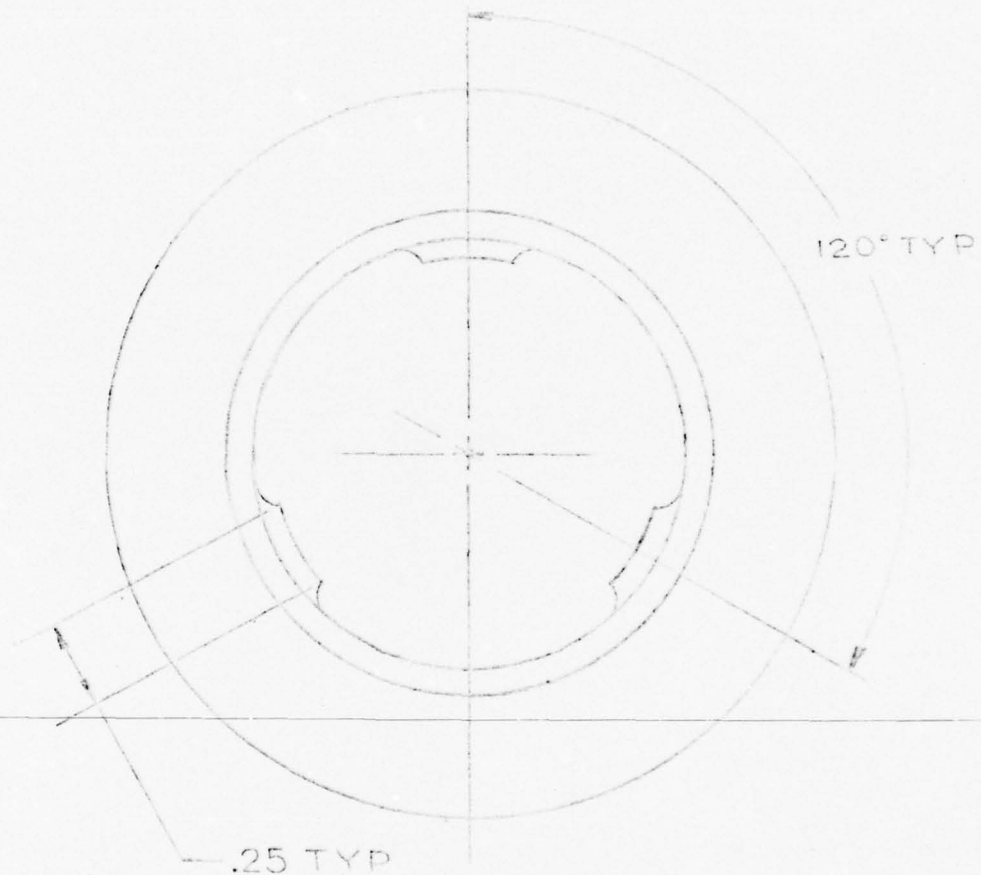
Figure 15. 206-040-349 Collar Final Configuration

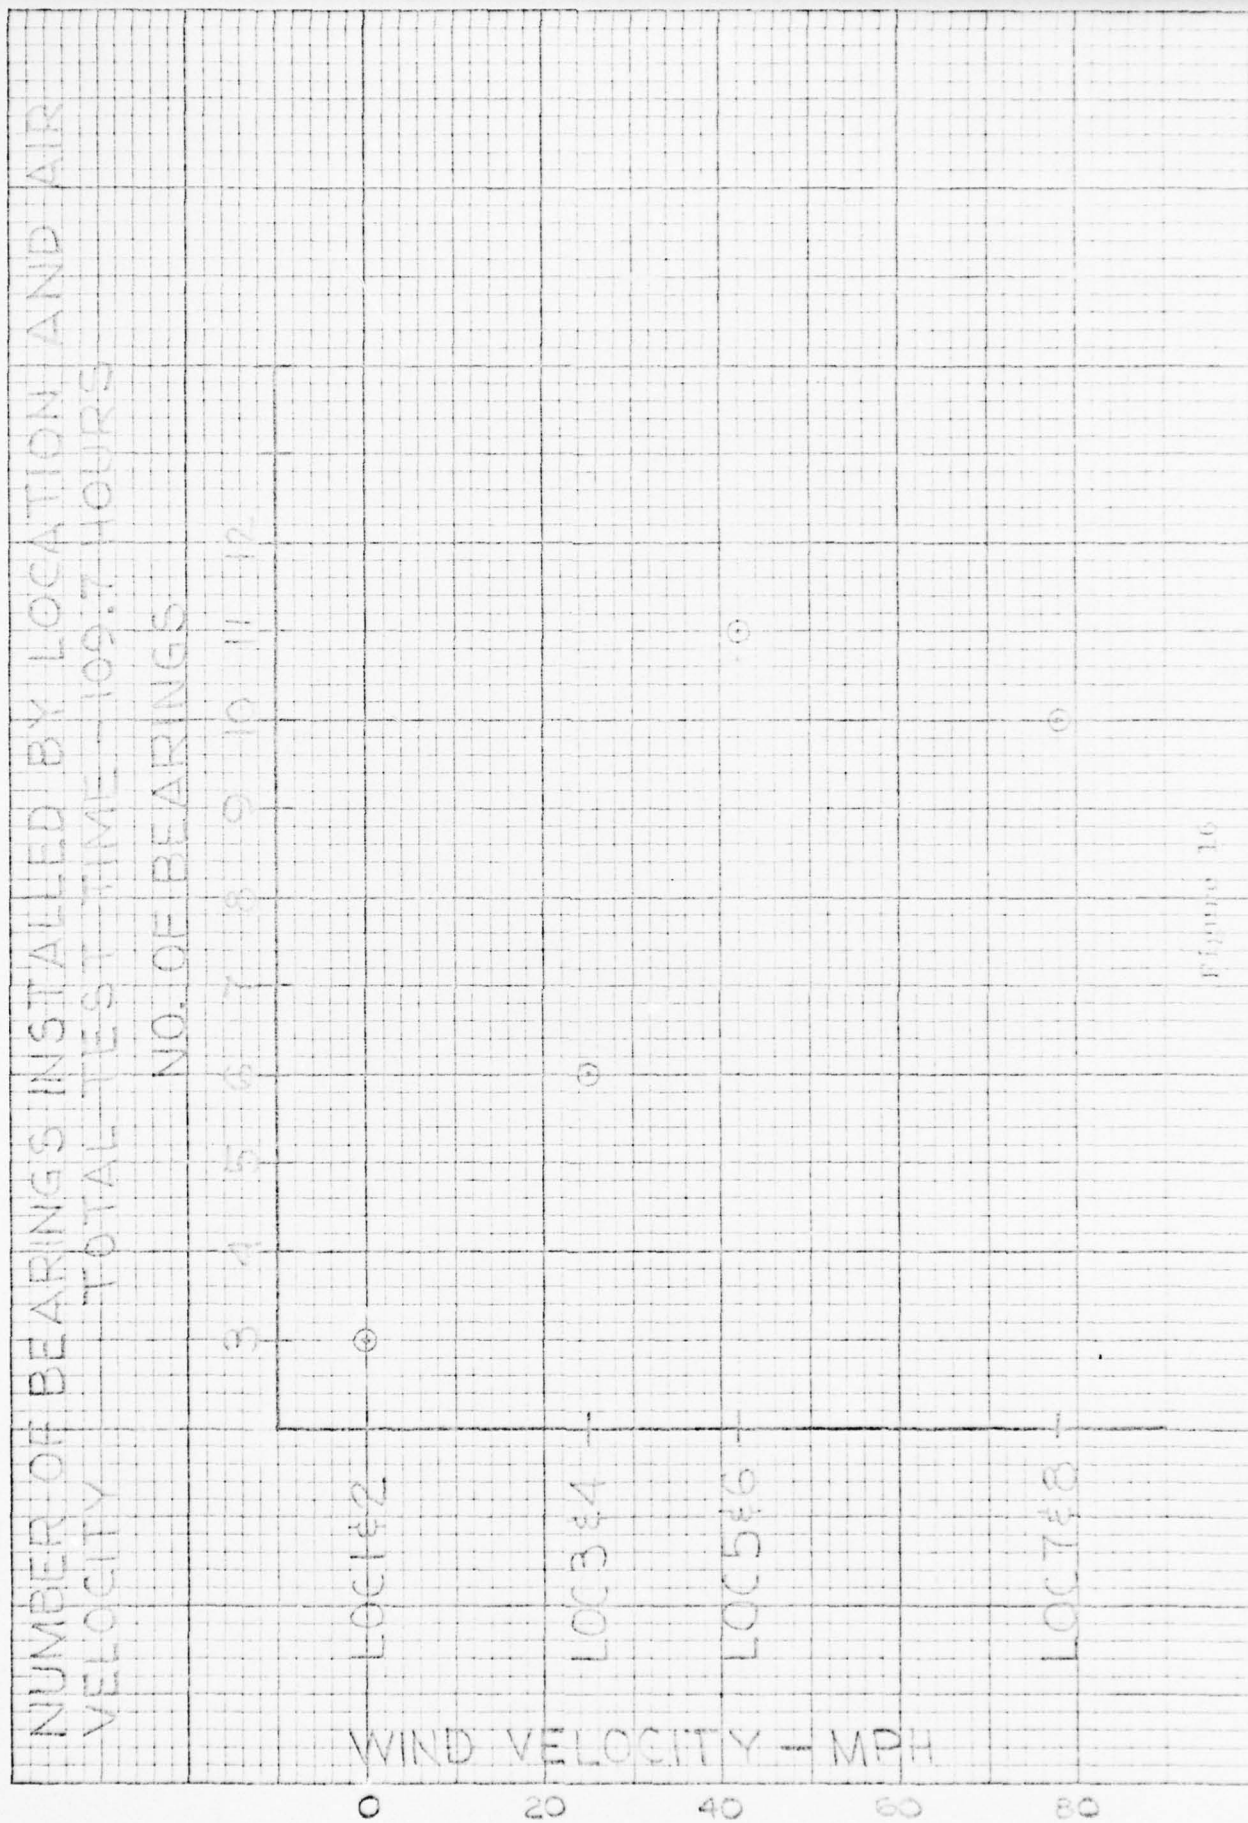
The affect of air velocity on the life of shielded bearings is demonstrated in Figure 16. There is an apparent peak affect at approximately 40 miles per hour, where eleven (11) failures occurred (locations 5 and 6). The influence of air velocity predominates over bearing load as evidenced by the load distribution shown in Table 1. Locations 5 and 6 are subjected to lower loads than locations 3 and 4, and yet 5 and 6 experienced a higher number of failures. Some variation of the failure distribution in Figure 16 may be expected with a change in load, especially at the higher velocity at locations 7 and 8, where ten (10) failures occurred with no measurable load.

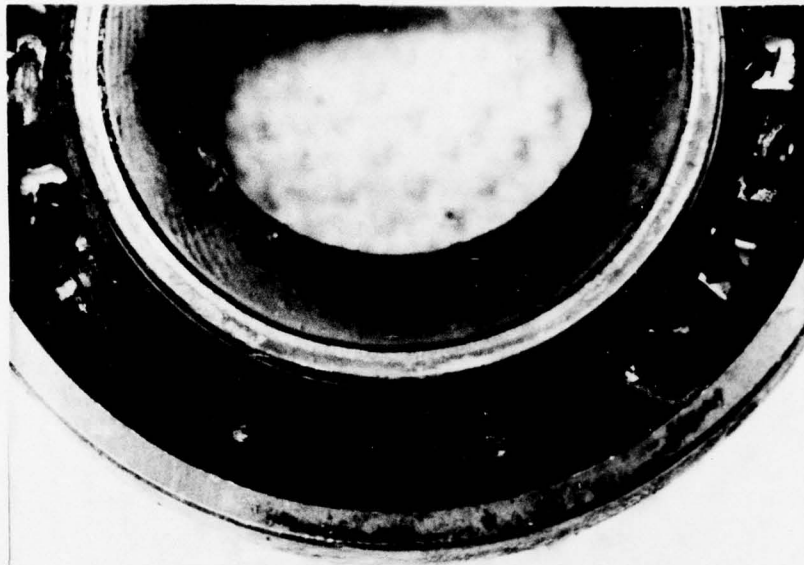
Figure 35. Bearing S/N TRL-10. Removed Position 2
With 20.4 Hours Time. 2.5x Enlarged View.

TRL-10	20.4	2	20.4	1	Bearing very rough. Fig. 31.
TRL-11	24.8	6	4.8	1	Bearing siezed and spun on collar. Figs. 32 and 33.
TRL-12	29.2	6	4.4	1	Bearing completely destroyed itself. Outer race spun in hanger. Fig. 34.

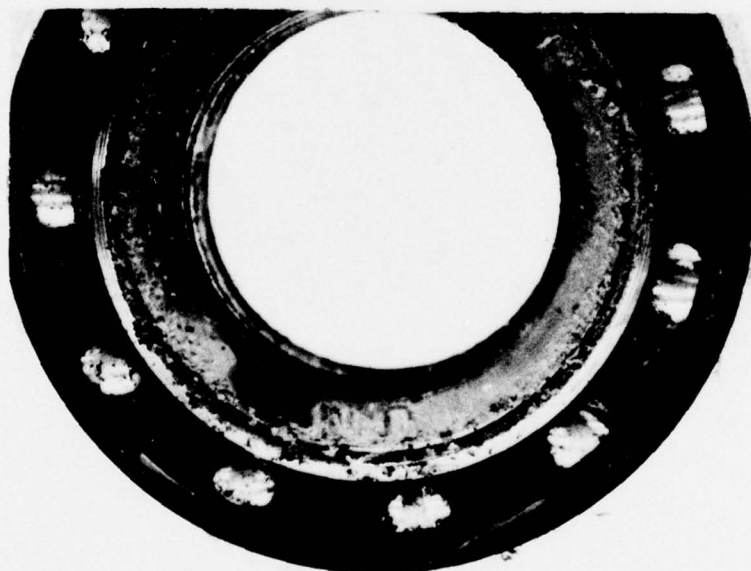
Figure 62. Bearing S/N TRL-24.
2x Enlarged View.

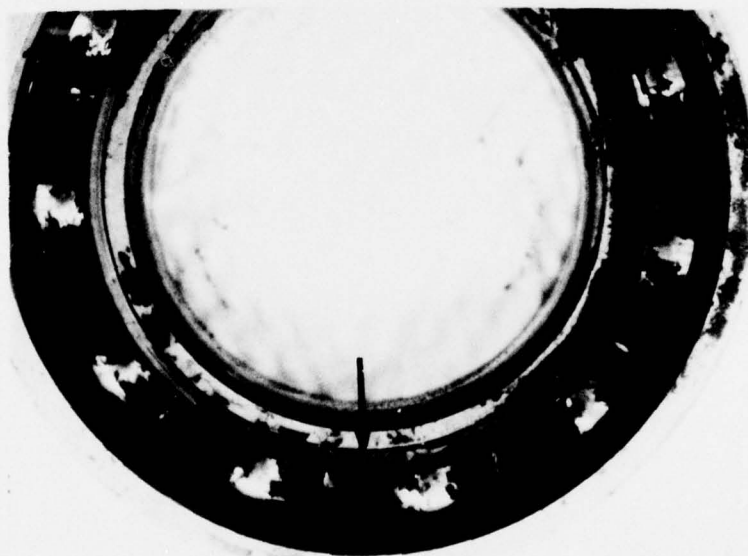
Figure 64. Bearing S/N TRL-26. Removed Position 7 With 11.0 Hours. 2x Enlarged View. Note Crack in Cage.

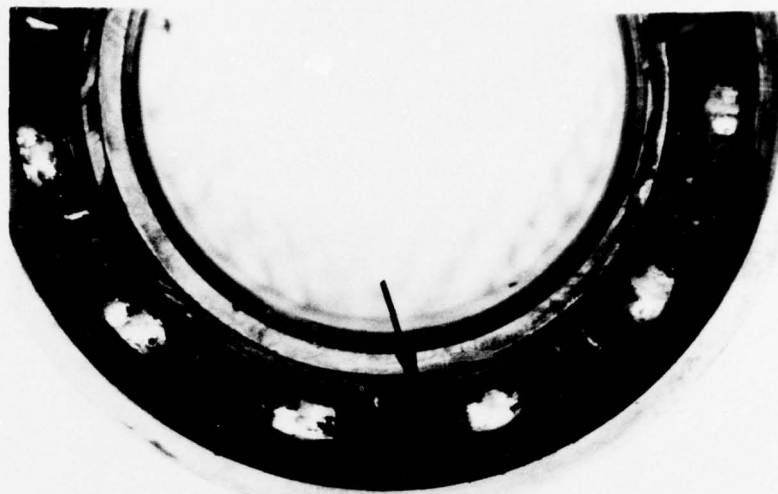
Figure 65. Bearing S/N TRL-27. Removed Position 8
With 14.5 Hours Time. 2x Enlarged View.
Note Crack in Cage.

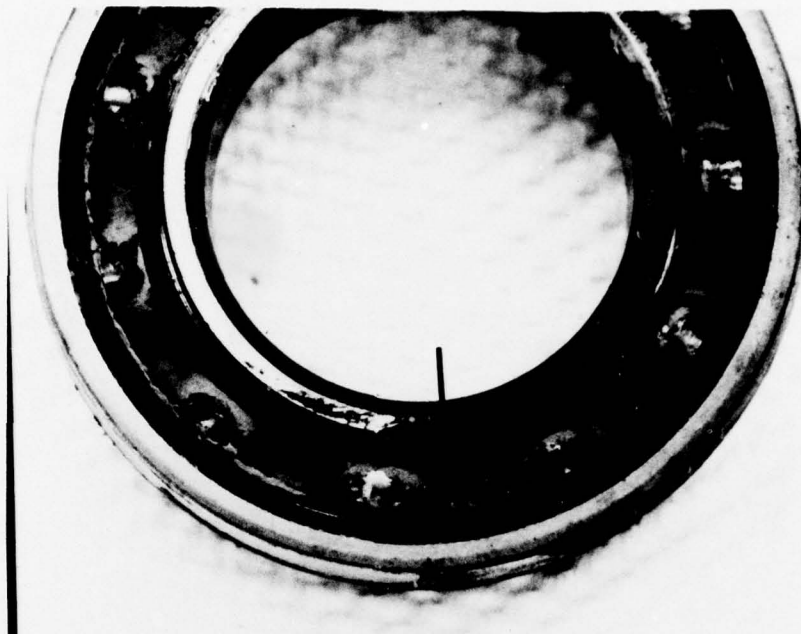
Figure 69. Bearing S/N TRL-31. 2x Enlarged View. Note Crack in Cage.

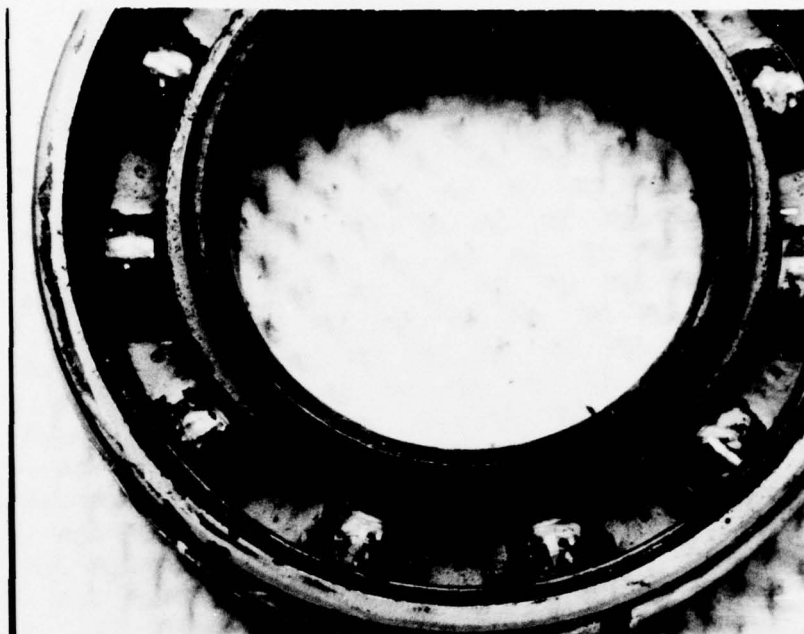
Figure 73. Bearing S/N TRL-40.
2x Enlarged View.

Bearing Test Serial Number	Test Time at Removal (Hours)	Position in Test Machine	Run Time on Bearing (Hours)	Bearing Assembly Configuration #	Remarks
TRL-22	41.0	3	29.4	3	Bearing siezed and spun on collar. Figs. 52-54.
TRL-26	52.0	7	11.0	3	Bearing very rough and cage just cracked. Fig. 60.
TRL-31	84.8	5	42.5	3	Bearing siezed and cut collar in two pieces, then severed shaft. Figs. 64-65.
TRL-40	106.7	3	64.4	3	Bearing siezed and cut collar in two. Figs. 68-70.
TRL-38	109.7	1	67.4	3	Bearing very smooth at removal for end of testing. Figs. 71-72.
TRL-27	56.8	8	14.5	4	Bearing very rough. Remaining grease hard and dry. Cage cracked. Fig. 61.
TRL-30	83.0	6	40.7	4	Cage blue but not cracked. Excessive internal clearance. Spun on collar. Figs. 62-63.
TRL-33	87.8	4	45.5	4	Bearing siezed and spun on collar. Figs. 66-67.
TRL-39	109.7	2	67.4	4	Bearing very smooth at removal end of test. Figs. 73-74.
